FSN & FSCA Ref: 24FA001  
Date: 28.02.2024

## **Urgent Field Safety Notice**

### **FLOWART® NEEDLE FREE VALVE SET WITH 1.2 MICRON FILTER**

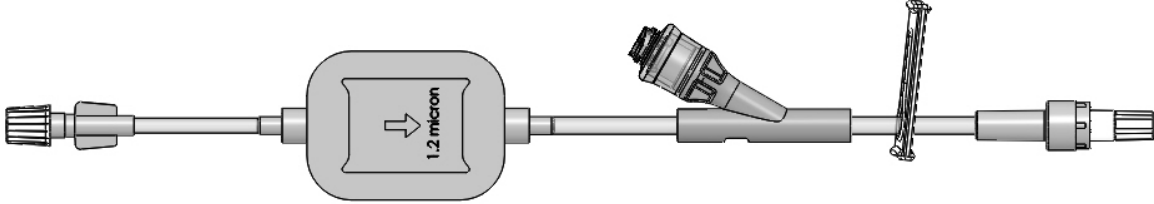
<b>1. Information on Affected Devices*</b>	
<b>1.1. Device Type(s)*</b>	Flowart® Needle Free Valve Set with 1.2 micron Filter is a sterile infusion therapy device equipped with a Y-site needle-free valve and an adult size 1.2 micron filter. Needle-free valve has a fully transparent clear housing with an integrated flat silicone seal and internal fluid pathway that protects the patient and nursing staff from exposures.

<b>2 Reason for Field Safety Corrective Action (FSCA)*</b>	
<b>2.1. Description of the product problem*</b>	The product problem involves kinking of the plastic tubing between the filter and the Y-site needle-free valve, which was observed in the packed product
<b>2.2. Hazard giving rise to the FSCA*</b>	The greatest hazard to both the patient and the end-user stemming from the observed kinking of the plastic tubing between the filter and the Y-site needle-free valve lies in the potential obstruction of fluid flow during intravenous therapy administration. This obstruction poses a significant risk of interrupting or impeding the delivery of essential fluids and medications to the patient. If the advice/action provided in the Field Safety Notice (FSN) is taken, which involves rectifying the kinking issue or replacing affected components, the residual risk is significantly mitigated.
<b>2.3. Probability of problem arising</b>

<b>3. Type of Action to mitigate the risk*</b>	
<b>3.1. Action To Be Taken by the User*</b>	
<input checked="" type="checkbox"/> Identify Device <input checked="" type="checkbox"/> Destroy Device	
<b>3.2. By when should the action be completed?</b>	Specify where critical to patient/end user safety
<b>3.3. Particular considerations for: Choose an item.</b>	
<p><b>Is follow-up of patients or review of patients' previous results recommended?</b> No</p> <p>The issue primarily pertains to the packaging and integrity of the product rather than its direct interaction with individual patients. While the kinking of the plastic tubing could potentially impact patient care during intravenous therapy, the root cause of the problem lies in packaging deficiencies rather than inherent product defects. The incident affects a specific batch of products with incorrectly sized primary packaging. Therefore, the number of patients directly impacted by the issue is limited. It's reasonable to assume that patients /healthcare personnel who received products from unaffected batches does not experience adverse effects related to the observed kinking issue. Asset's containment measures, such as halting distribution or recalling affected products, are aimed at preventing further distribution and usage of potentially compromised devices. By addressing the root cause and containing the problem at the source, the immediate risk to patients is mitigated. Without patient-specific data or adverse event reports directly linking the packaging issue to patient harm, individual patient-level follow-up is not deemed necessary. The focus of remedial actions is on correcting the packaging deficiency and ensuring product integrity rather than monitoring individual patient outcomes.</p>
