URGENT: FIELD SAFETY NOTICE

Medima Infusion Pump

9th January 2025

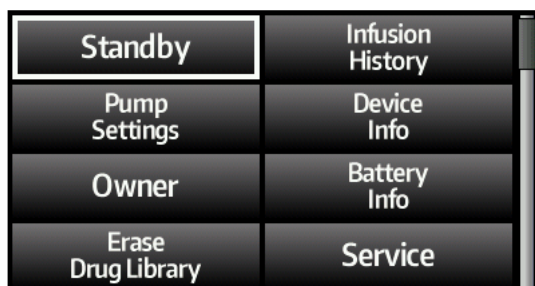
There is no need to return or discontinue using your Medima infusion pumps. When using the pump, all instructions, including warnings and cautions in the device User Manual, must be followed. Please select the “Device info” tile on the Options menu to identify the pump software version. Select the “Menu” button on the alphanumeric keypad when the pump is turned OFF and connected to an external power supply to access the Options menu.
