**New Field Safety Notice**

**Urgent Medical Device Correction – Pitch Cable Failures on da Vinci X and Xi Tenaculum Forceps and Small Graptor™ (ISIFA2024-10-C)**

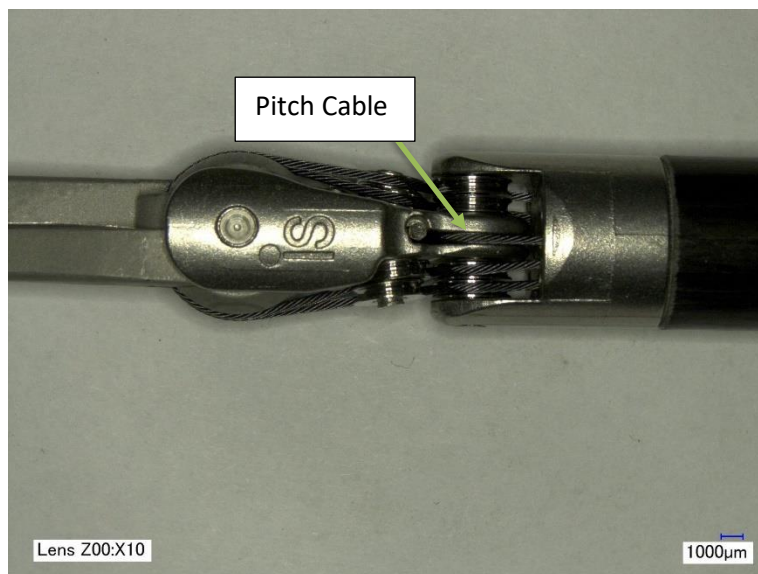
**Figure A: 10x Magnified example of an intact pitch cable on an da Vinci Xi Tenaculum Forceps instrument.**

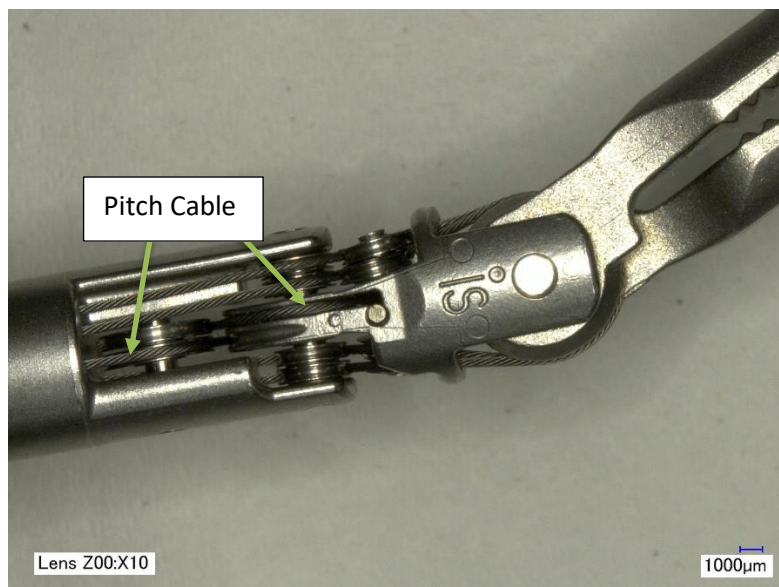
**Figure B: 10x Magnified example of an intact pitch cable on an da Vinci Xi Small Graptor instrument.**

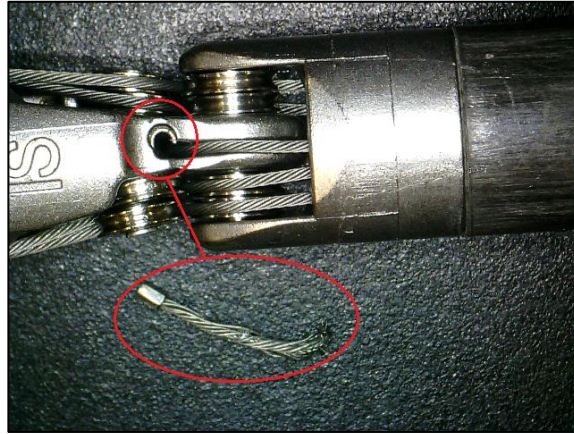
A pitch cable can fail partially (i.e., frayed) or completely (i.e., broken). A broken pitch cable can lead to loss of pitch functionality, exposure to frayed cables, or the potential for tungsten cable particulate to fall into the patient. Pitch cable failure may also result in a fragment of the pitch cable and its end-crimp becoming dislodged from the instrument (See Figure C).

**Figure C: Example of a pitch cable fragment.**

Both the Tenaculum Forceps and Small Graptor use an end crimp design at the distal end, where if the pitch cable breaks it is possible for a segment of the crimp side of the cable to fall out as a fragment and into the patient.

If the instrument fails during surgery, there is potential for a fragment to separate from the pitch cable as shown in Figure C. Visible fragments can be extracted by the surgeon with surgical instruments or irrigated and suctioned out of the patient. Such attempts to retrieve material could lead to a prolonged surgery. Retrieval of fallen particulate by the user may incur a minor procedure delay (< 30 minutes).

If you experience a cable failure, please be sure to inspect for any fragments before completing the procedure.

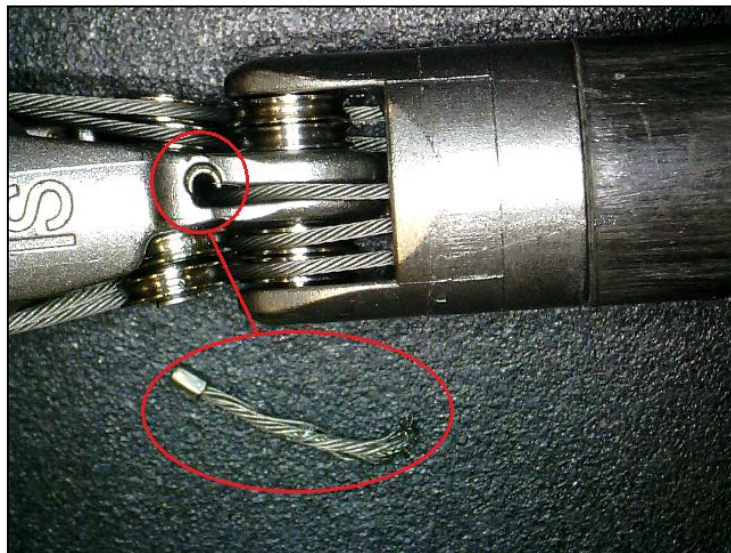
Figure E: Example of a pitch cable fragment.

Prior to use, visually inspect all instruments for broken or frayed cable per Figure E, F and G below

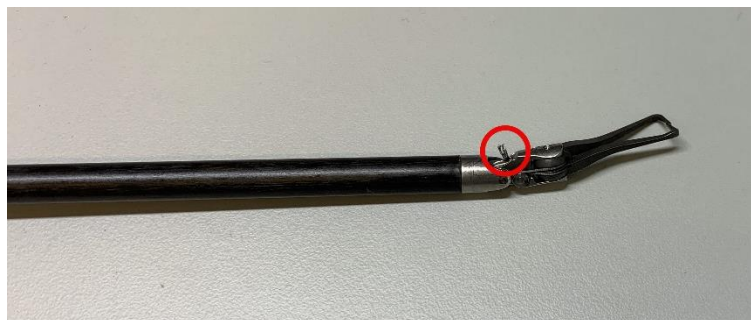
Figure F: Broken Pitch Cable

- If an instrument with a broken pitch cable is installed on the system, it could result in engagement failure which will be immediately detected by the surgeon.
- If a pitch cable breaks intraoperatively on an installed instrument, the failure would be immediately detected by the surgeon as it would result in imprecise motion. For example, the surgeon could command a motion at the hand controls, but the instrument may not respond as expected. Imprecise motion may manifest as reduced ability to retract tissue. If the affected instrument was grasping tissue at the time of cable breakage, the position of the grasped tissue may change due to gravity.

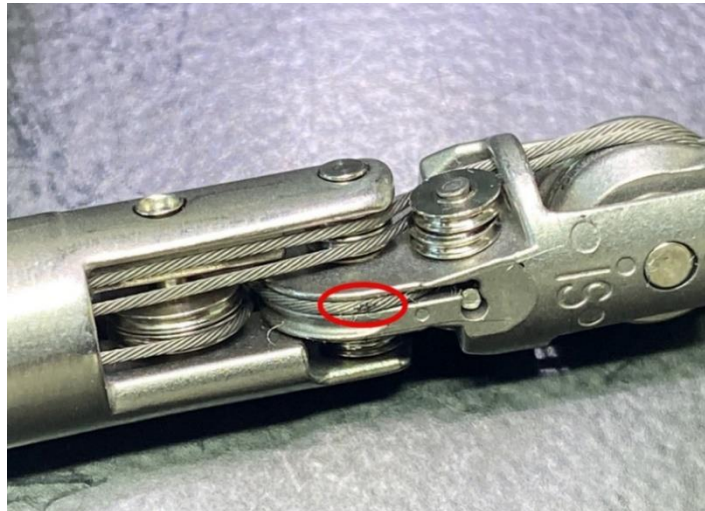
Figure G: Frayed Pitch Cable

- Frayed pitch cables may be identified through endoscopic view. Existing frayed pitch cable failure will not result in affected pitch motion as the pitch cable will remain connected.
- Frayed cables that are not visually identified would be unlikely to cause any unintended tissue interactions.
