URGENT Field Safety Notice

Philips Azurion and Allura with 1 Phase UPS
Potential Loss of System Functionality

3rd August 2025

Reference: 2024-IGT-BST-009: Philips Azurion and Allura with 1 Phase UPS
Potential Loss of System Functionality

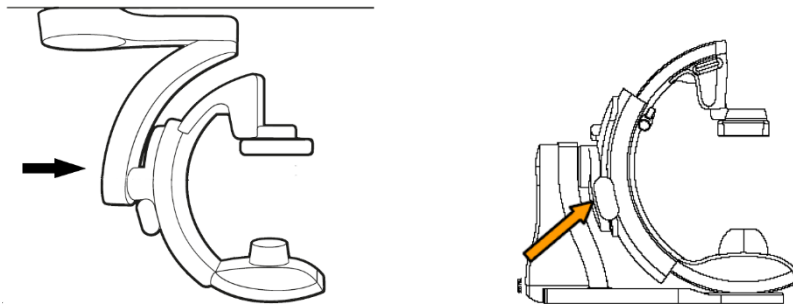
Figure 1: Location of the System identification label

The Product Number and Product Name can be found on the System Identification Label (Figure 1).
