<Reference: 97125289E-FA>

20 August 2025

## Urgent Field Safety Notice

**Subject: Field Safety Notice** – Software to enhance Safety Architecture is available and designed to prevent initiation of Safety Mode in an ambulatory setting due to a high battery impedance state for the ACCOLADE™ family of devices which includes ACCOLADE, PROPONENT™, ESSENTIO™, and ALTRUA™ 2 dual chamber (DR) standard life (SL) and DR extended life (EL) pacemakers; and VISIONIST™ and VALITUDE™ cardiac resynchronization therapy pacemakers (CRT-Ps). (Boston Scientific Field Action Reference: 97125289E-FA).

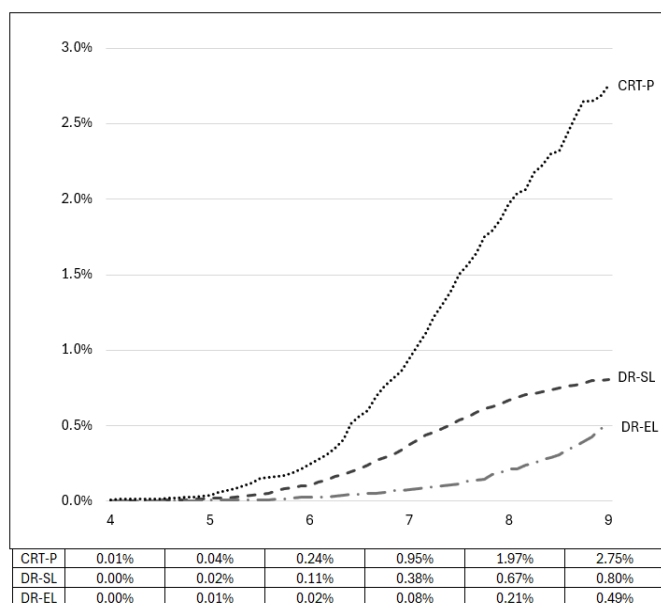
The worst case reported patient harm has been loss of pacing with serious injury or life-threatening outcome. There have been two (2) deaths in pacemaker dependent patients after initiating Safety Mode in an ambulatory setting and no additional deaths have been reported since that time. Details about the ACCOLADE subpopulations and projected lifetime occurrence rate for each device type are reported in Table 2. Occurrence rates for various device types are reported in Figure 1 and 2.

**Figure 1** Occurrence rates for high battery impedance induced Safety Mode in the December 2024 advisory population

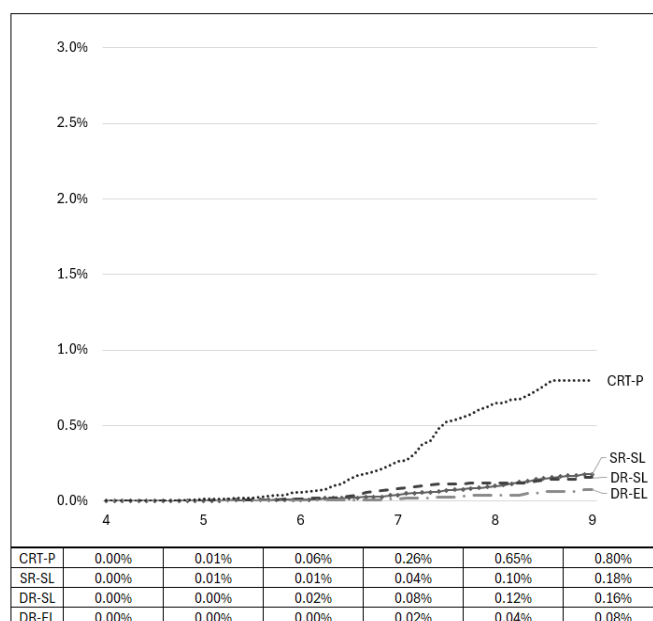
**Figure 2** Occurrence rates for high battery impedance induced Safety Mode in remaining devices
