IMPORTANT PRODUCT NOTICE

9<sup>th</sup> September 2025

**Reference:** C&R 2024-IGT-BST-022 - Potential temporary loss of motorized movements due to firewall router not installed

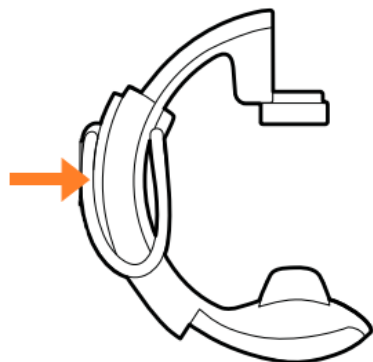
Figure 1: System Identification label

The System Product Name and Model Number can be found on the System Identification Label located on the System stand (refer to Figure 1). The software version of the Philips Azurion system can be identified during startup (refer to Figure 2).
