Template Rev 2: February 2020  
CellaVision FSCA Ref: CA25-013  
CellaVision FSN Ref: FSN-CV-2025-004-ROW

Date: 2025-10-10

**Field Safety Notice**  
**Automated Digital Cell Morphology Analyzer DI-60**

**Field Safety Notice (FSN)**  
**Automated Digital Cell Morphology Analyzer DI-60**  
**Barcode reader issue**

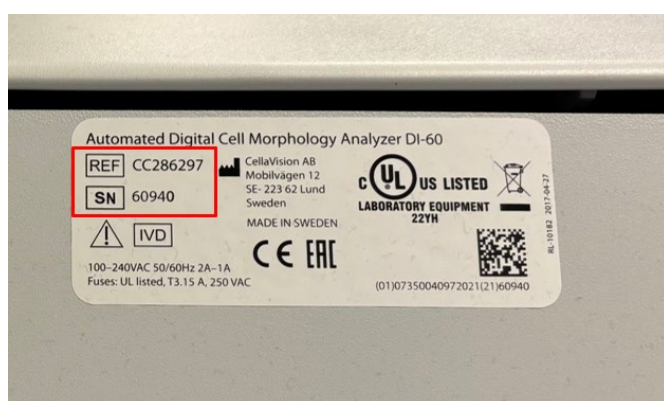
Affected units listed below in Table 1, please refer to Figure 1 and 2 for information on how to identify your unit.

*Figure 1. Example of label with REF and SN.*

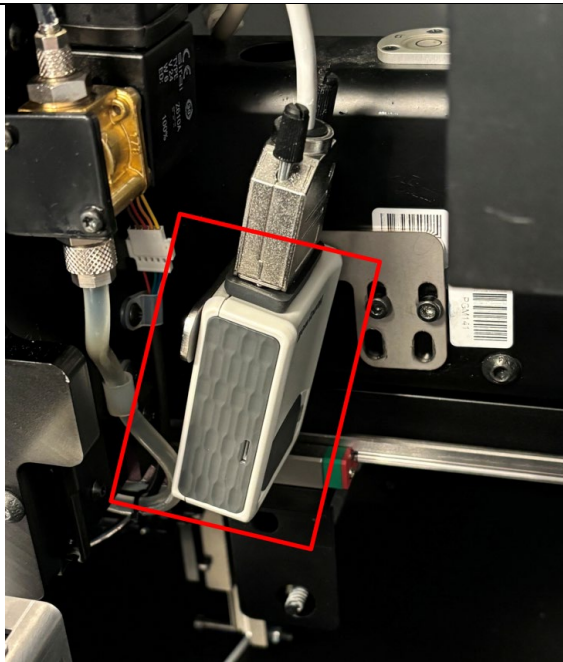
| Reference number (REF) | Serial number (SN) | Barcode Reader |
|---|---|---|
| CC286297 | 60001 – 63219 or<br>CN60001 – CN63219 | Units affected only if they have had their original barcode reader replaced with a Honeywell Vuquest. |

Figure 2. Image of the Honeywell Vuquest barcode reader installed in system.

| | <p>Action (FSCA) is being initiated to mitigate the risk and ensure continued patient safety.</p> <p>Internal investigation has confirmed that the malfunction is caused by conditions in the CCU firmware in combination with newer barcode readers (Honeywell Vuquest and Jada FM-5).</p> <p>Specifically, the barcode reader has a field of view that is too large, allowing capture of the barcode on the return slide (located next to the fetch slide). The barcode reader continues to attempt barcode reading after the gripper has released the return slide, thereby exposing its barcode. To eliminate the root causes, corrective actions have been implemented in the CCU firmware (version 4.2.7), which includes:</p> <ul style="list-style-type: none"><li>- Reducing the effective field of view of the barcode reader.</li><li>- Preventing additional barcode reading attempts once the gripper has released the return slide.</li></ul> <p>Firmware version 4.2.7 has already been introduced in manufacturing. As part of this FSCA, all affected DI-60 instruments in the field will be updated with the corrected firmware via Distributor's service engineers. Distributors are required to confirm completion of the update.</p> <p>These actions are justified to prevent recurrence of the malfunction, to mitigate the risk of slide misidentification, and to ensure patient safety.</p> |

| | <input checked="" type="checkbox"/> On-site device modification/inspection<br><input checked="" type="checkbox"/> Software upgrade<br><br>A new Firmware (version 4.2.7) has been developed to solve the problem associated with the barcode reader. This new version shall be installed in affected units through a Field Safety Corrective Action. The installation will be performed by Sysmex service personnel, who will contact affected users to schedule a time for firmware update. Refer to Technical Note TN-148 for information and details regarding the Field Safety Corrective Action. | |
