**IMPORTANT FIELD SAFETY NOTIFICATION****URGENT: MEDICAL DEVICE CORRECTION**

**Subject:** MOSAIQ may fail to load adapted Baseline Shift Plan during Unity treatment delivery when a communication error occurs during the send process.

**Product:** MOSAIQ with Unity

**Scope:** Unity customers with MOSAIQ v 3.2.1.0 to 3.2.3.2

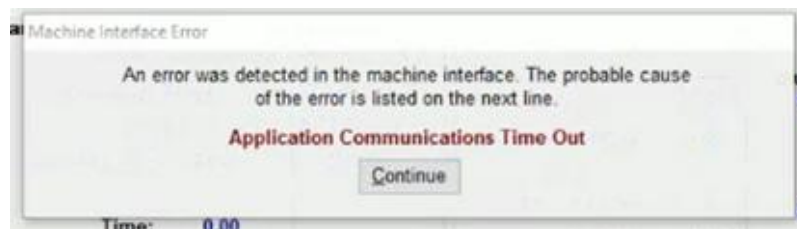
Figure 1, Machine Interface Error Message

If an "Application Communication Time Out" error message (Figure 1) appears during a BLS plan transfer, click Continue, then:

1. Navigate to the treatment delivery table.
2. Right-click on the relevant field and select Field Delta from the pop-up menu (Figure 2).
3. If the field has changed, as expected, a warning message will be displayed (Figure 3), click Yes to show details.
4. In the details window (Figure 4), check that the timestamp for the last edit matches the time of the last BLS transfer from Monaco.
5. If the Field Delta indicates that the field has changed with the expected timestamp, treatment delivery can continue.
6. If questions remain following review of the Field Delta, end the current treatment session and continue with the Completion Plan workflow.
