## **URGENT Field Safety Notice**

### **Philips Azurion and Allura Systems**

Potential loss of imaging functionality (Allura/Azurion), loss of motorized movement (Allura), or loss of data (Allura) due to aging Hard Disk Drives

<08-05-2026>

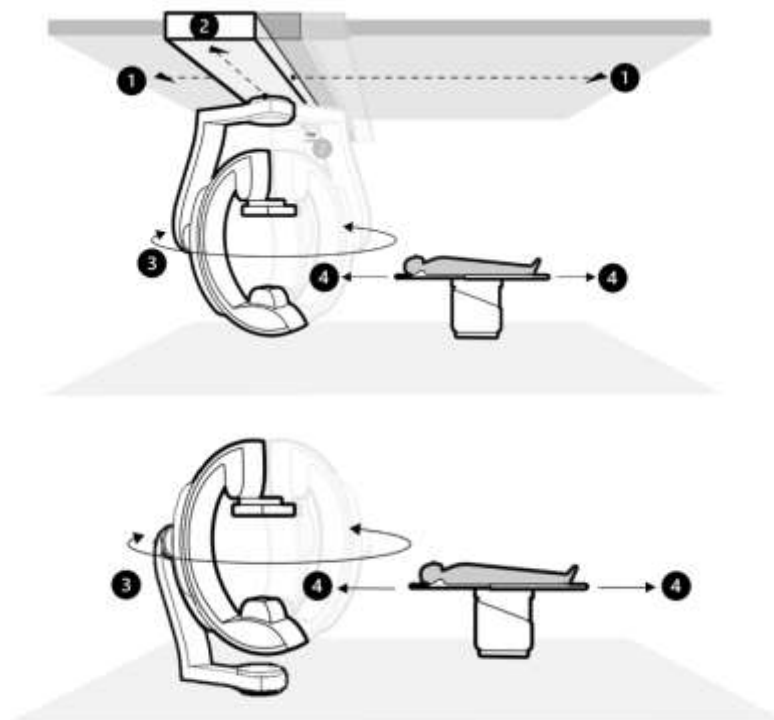
Figure 1 – Manual movements of the ceiling-mounted system (top) and floor-mounted system (bottom)

- Circulate this Urgent Field Safety Notice to all users of the system so that they are aware of the issue and follow the instructions below.
- In case motorized movements are unavailable, the stand can be manually repositioned using the handgrips and brake controls located on both sides of the stand. For ceiling-mounted systems, manual longitudinal (1), transversal (2) and rotational (3) stand movements remain available. Note: Transversal stand movements (2) are only available for ceiling-mounted systems with the FlexMove option. For floor-mounted systems, only rotational (3) stand movements remain available. The table longitudinal position (4) can be adjusted manually, when the table is not tilted (see Figure 1 below).

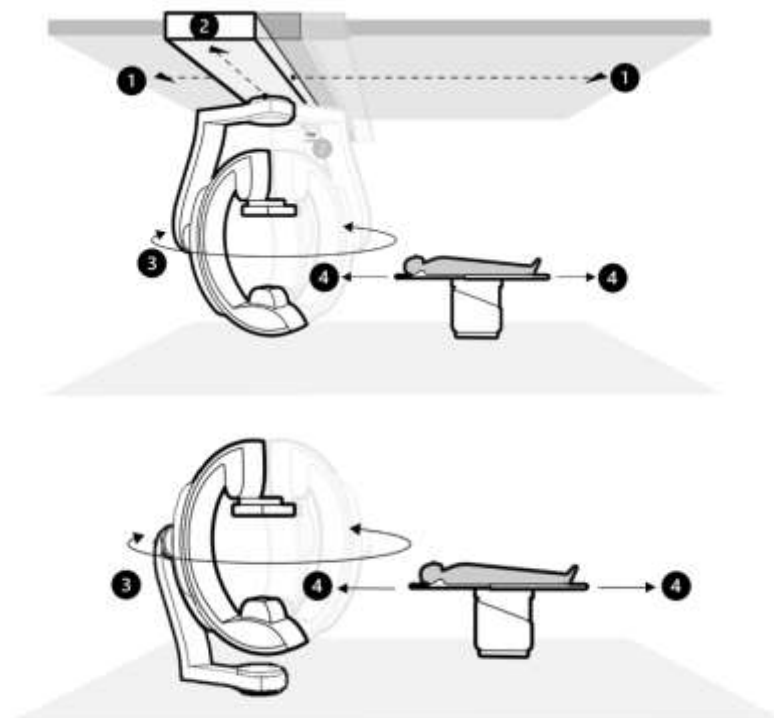
*Figure 1 – Manual movements of the ceiling-mounted system (top) and floor-mounted system (bottom)*

- Circulate this Urgent Field Safety Notice to all users of the system so that they are aware of the issue and follow the instructions below.
- In case motorized movements are unavailable, the stand can be manually repositioned using the handgrips and brake controls located on both sides of the stand. For ceiling-mounted systems, manual longitudinal (1), transversal (2) and rotational (3) stand movements remain available. Note: Transversal stand movements (2) are only available for ceiling-mounted systems with the FlexMove option. For floor-mounted systems, only rotational (3) stand movements remain available. The table longitudinal position (4) can be adjusted manually, when the table is not tilted (see Figure 1 below).
