DATE: 11<sup>th</sup> August 2026 **FSCA/FSN REF.: APM-26-06129**

**URGENT: FIELD SAFETY NOTICE (FSN)**  
**ForeSight Oximeter cable**

| Product name | Product Code (REF) | Lot number / Serial number | UDI-DI |
|---|---|---|---|
| ForeSight Oximeter cable | HEMFSM10 | All serial numbers manufactured between June 01, 2021, through June 30, 2026 | 00690103210927 |

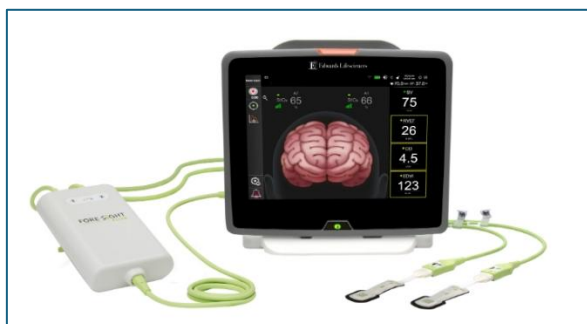
Based on customer feedback, BD has identified that during manufacturing, the laterality identification labels may be missing or inaccurately placed on the device. There is potential that the labels on the green cables may have been switched, with the channel 1 cable labelled as channel 2, and the channel 2 cable labelled as channel 1 [CS4.1][KL4.2]. This will lead to a mismatch as to the left and right values displayed on the monitor and what the labels indicate on the cables.

The white module with attached green cables that connects to the HemoSphere monitor and the ForeSight sensors.

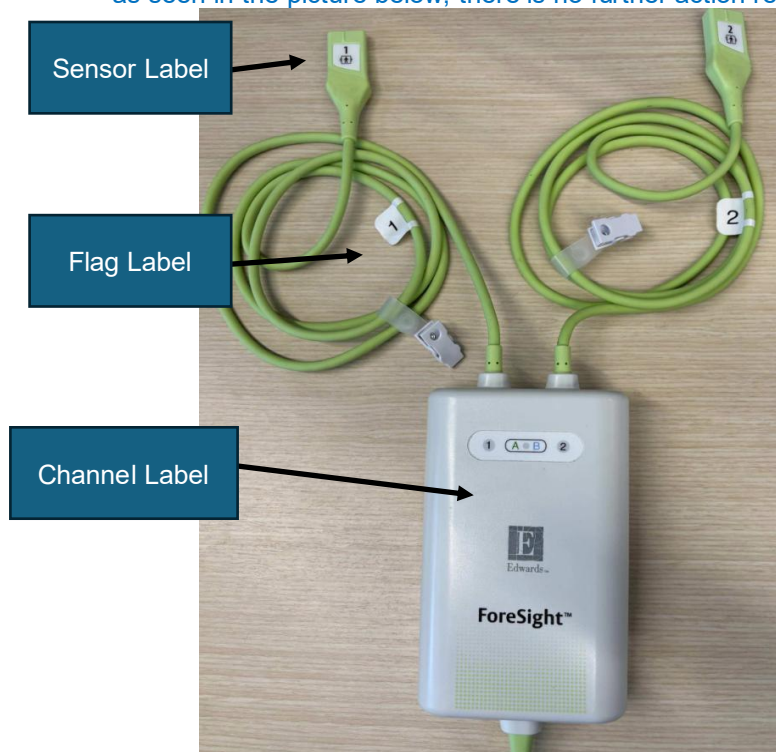
Should this potential issue occur during use, the values displayed on the monitor will be switched and will represent the opposite region

| Type of Action to mitigate the risk | | | | | | | |
|---|---|---|---|---|---|---|---|
| Provide further details of the action(s) identified | | | | <p>If either of the labels are missing, or the flag label and/or the sensor label do not match the channel label on the housing, quarantine the device and return the completed response form to BD at <a href="mailto:BDFieldActions@bd.com">BDFieldActions@bd.com</a> for BD Technical Services to contact you.</p> | | | |

1. Verify for the presence of the flag, sensor, and channel labels on the device.
2. Verify that the flag and sensor labels correspond to the correct channel label (A1 on left / B2 on right) on the housing (See picture below for correct label placement).
3. If either of the labels are missing, or the flag label and/or the sensor label do not match the channel label on the housing, quarantine the device and return the completed response form to BD at [BDFieldActions@bd.com](mailto:BDFieldActions@bd.com) for BD Technical Services to contact you.
4. If the flag and sensor labels correctly correspond to the channel labels, as seen in the picture below, there is no further action required.

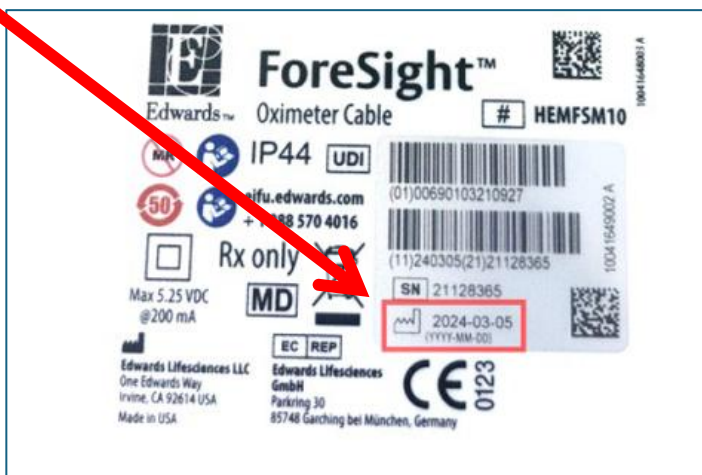
## Appendix 1 – Manufacturing date identification

This issue may affect certain devices manufactured between June 01, 2021, and June 30, 2026. Refer to the following image to identify the location of manufacturing date.
