## Field Safety Notice

Magnetic Resonance (MR) imaging systems with Diffusion Tensor Imaging (DTI)  
Incorrect data in Enhanced MR DICOM Export

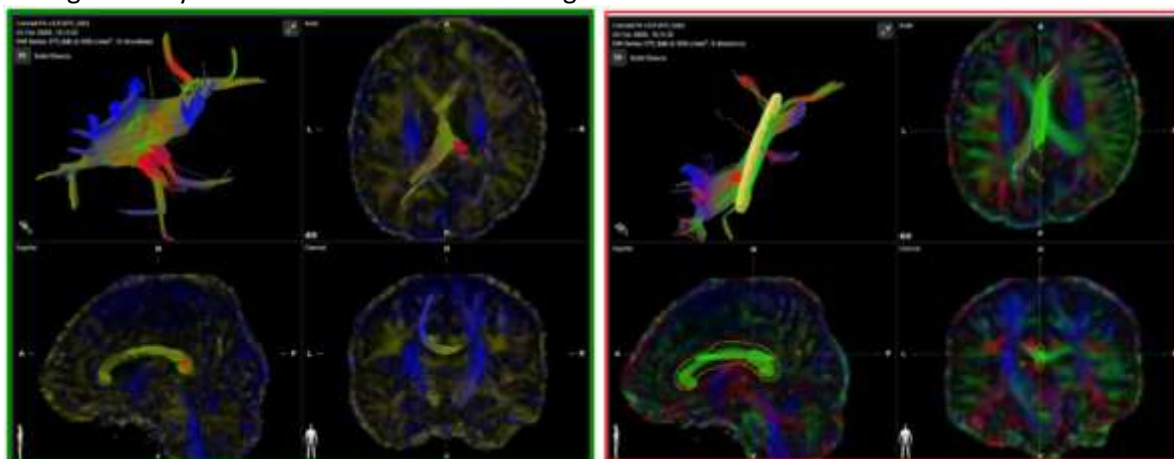
When exporting diffusion tensor imaging (DTI) scans from a Philips MR system using the Enhanced MR DICOM format, the exports contain incorrect data (diffusion directions). If the Enhanced MR DICOM export is used in conjunction with third-party software for tractography (e.g. for mapping nerve fiber pathways in the brain), the software will not be able to correctly process the DTI data for reconstruction (see Figure 1).

Figure 1. Example of a correct reconstruction image (Left) and an incorrect reconstruction image (Right) resulting from processing an Enhanced MR DICOM export with incorrect data. The image on the right clearly exhibits abnormal fiber tracking.

- To prevent the issue from occurring while Philips is developing the software solution, use the Classic DICOM transfer option for exporting DTI scans (see instructions below).
  - Open the **DICOM Configuration**, click **Settings and Tools (F10)**

A Philips representative will contact you to schedule time for a Field Service Engineer (FSE) to install a software upgrade to resolve the issue (reference 2026-PD-MR-014).

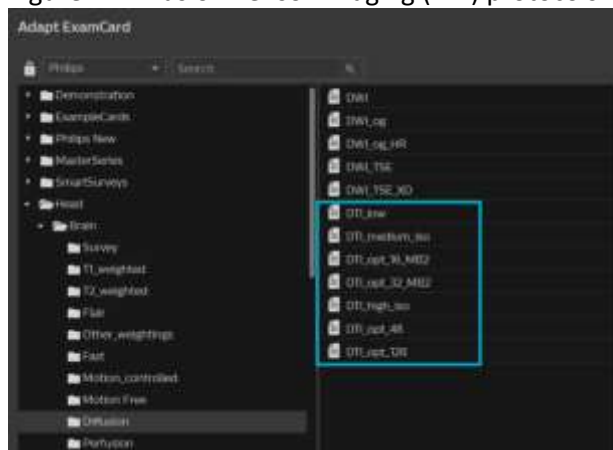
### Figure 2. Diffusion Tensor Imaging (DTI) protocols

To identify if your system has Diffusion Tensor Imaging (DTI), navigate to the **Philips\Head\Brain\Diffusion** folder within the Philips protocol database and verify if your system contains the protocols shown in Figure 2.
