URGENT Field Safety Notice

Philips MR system breast coils
Potential for harm while using a breast coil

October 31, 2024

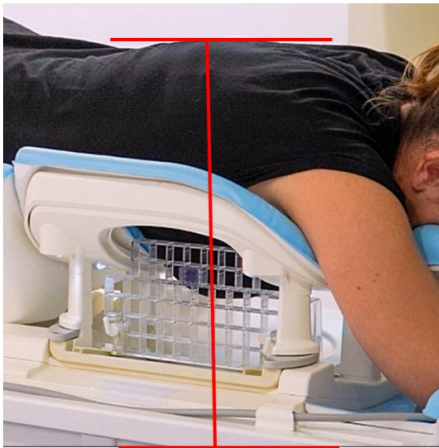
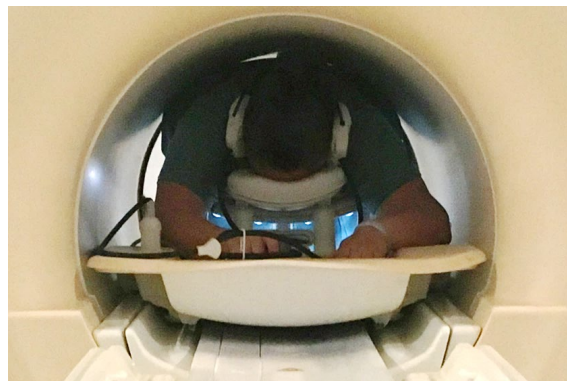
Philips has identified an issue with patient set up while using the MR system breast coil where, if the cross-section of the prone patient, breast coil, and patient table exceeds the internal diameter of the magnet bore, the patient may be compressed between the breast coil and top of the magnet bore potentially resulting in harm to the patient (see Image 1).

Image 1: (Left) *Cross-section: combined measurement of patient height, breast coil, and table. Must not exceed the internal diameter of the magnet bore.* (Right) *Incorrect patient set up: patient is touching/pressed against the side of the bore.*

- A. Customers can continue using the identified systems in accordance with the intended use.
- B. When using the system:
 - Follow section *PRECAUTIONS, CAUTIONS & WARNINGS* in the Instructions For Use (IFU) provided with your coil:
 - i. When using breast coils if the patient’s back touches the bore and stops the table movement, do not manually force the table to iso center, this could cause injury to the patient.
 - ii. When positioning the coil on the table and the patient in the coil, always check that the coil and/or the patient will not hit the bore when moving the table, this could result in patient injury. Refer to the system Instructions for Use for positioning instructions.
 - Follow section *Positioning>Safety* in the IFU: Ensure clearance between body parts and the bore wall.
