**URGENT - FIELD SAFETY NOTICE – RECALL**  
**Extended Tip Applicator (XTA) (ref. 205108 and 205115)**

The Extended Tip Applicator (XTA) is a sterile single-use device consisting of a malleable shaft and a permanently attached spray tip.  
It is used for the controlled application of two liquids.

Integra LifeSciences is voluntarily issuing this Field Safety Notice for the recall of **Extended Tip Applicator (XTA)** listed in Table 1.

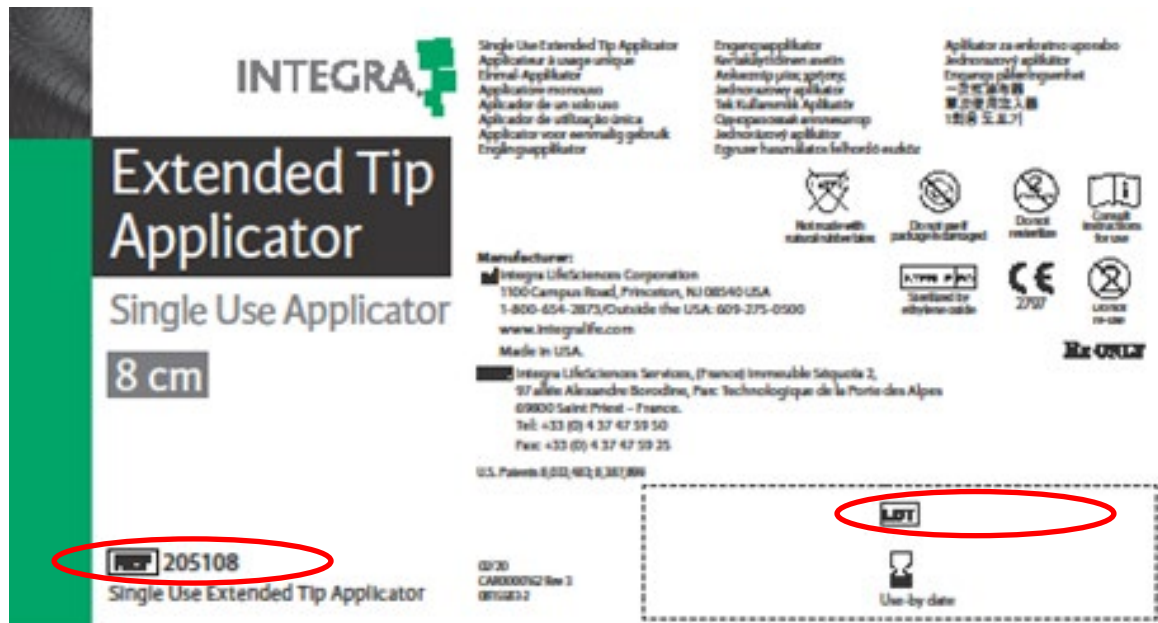
## Appendix 2: Product Label sample

Reference 205108. Use Red Circle below to Identify Lot Number

**Appendix 2:** Sample of a product label Product Label for Part # 205108 (1 page). Use Red Circle below to Identify Lot Number
