Subject: URGENT - FIELD SAFETY NOTICE – INTEGRA – CUSA® Excel 23KHz Straight Handpiece – Reference: C2600 – FIELD SAFETY ACTION

Legal manufacturer: Integra Lifesciences, IDA Business and Technology Park, Sragh Ave, Tullamore, Co. Offaly – IRELAND. IE-MF-000003849

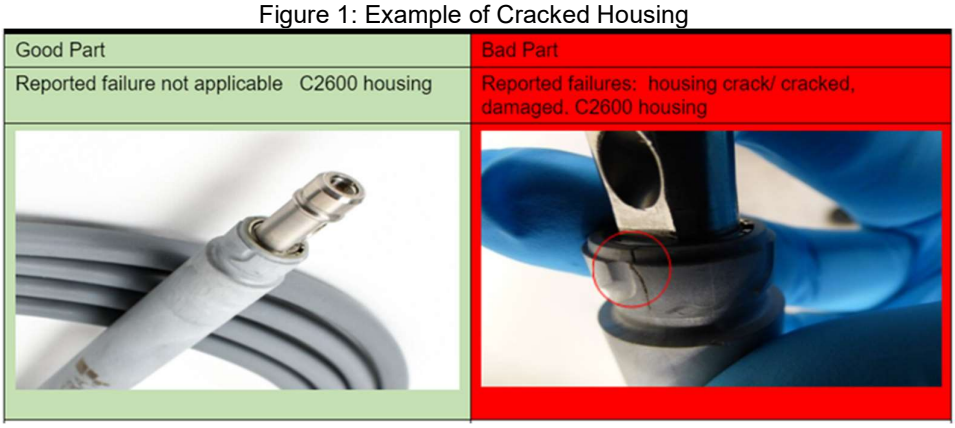
The decision to conduct a voluntary correction of the product was based on the following: through an internal investigation of customer complaints, it was identified that there is a potential for the CUSA Excel 23KHz Handpiece housing to crack. In order to mitigate this issue, the devices will be reworked through our service and repair process for the units manufactured prior to November 2023.

1. Inspect the housing for the presence of a crack – see image below.

Figure 1: Example of Cracked Housing

2. The Handpiece cracked housing may be visually detected by clinical staff during inspections prior to or post-surgery. If a crack is noted, please remove the handpiece and return to Integra Service. TCS Benelux TCS.Benelux@integralife.com; TCS DACH TCS.DACH@integralife.com; TCS France TCS.France@integralife.com; TCS Italy TCS.Italy@integralife.com; *(will be added to the corresponding FSN depending on the country*). Check the box "I do have affected units" in the enclosed the reply form.
3. If a crack is not noted,

Regardless of the service contract status, the housing will be replaced free of charge during your next service.
