Urgent Field Safety Notice

SynchroMed™ A810 Clinician Programmer Software Application v2.x.

Medtronic Reference: FA1440

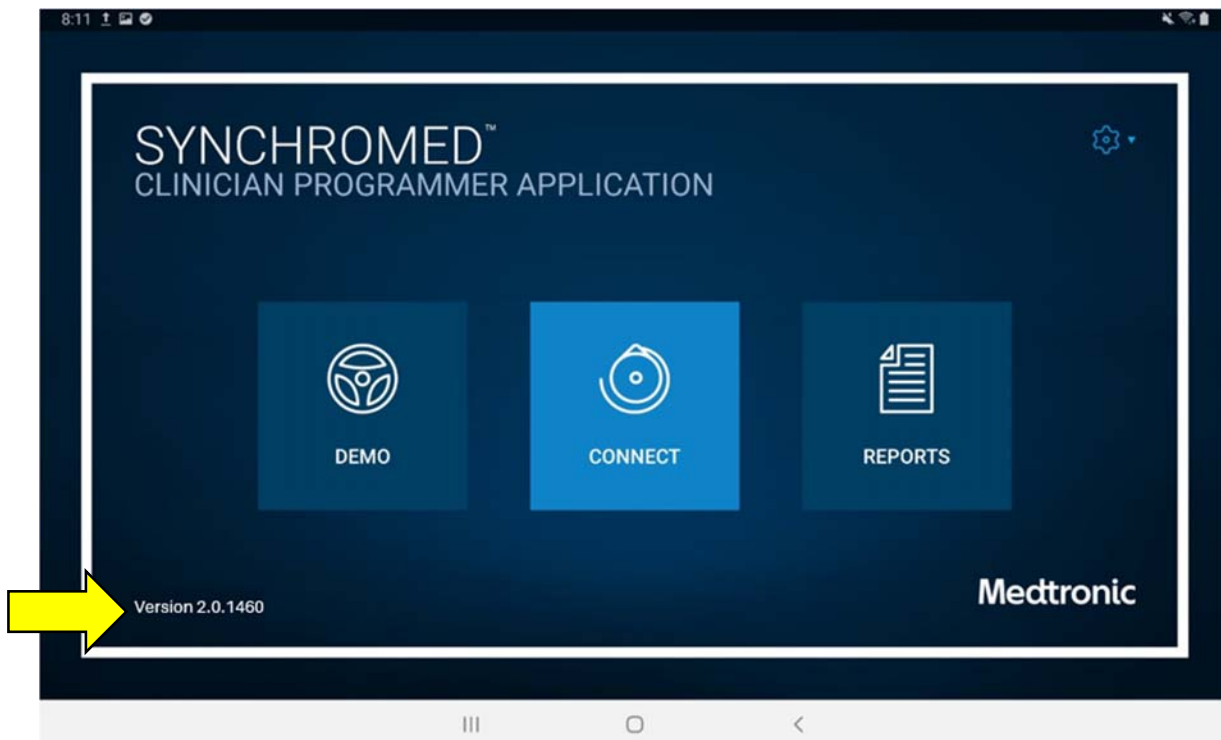
The version of the A810 CP app software can be found in the lower left corner of the of the Main Menu screen, an example is shown below.

Identifying the A810 CP app version
