## Field Safety Notice

MR systems with SW versions R5 & R11  
Potential scan abort during an examination

August 2026

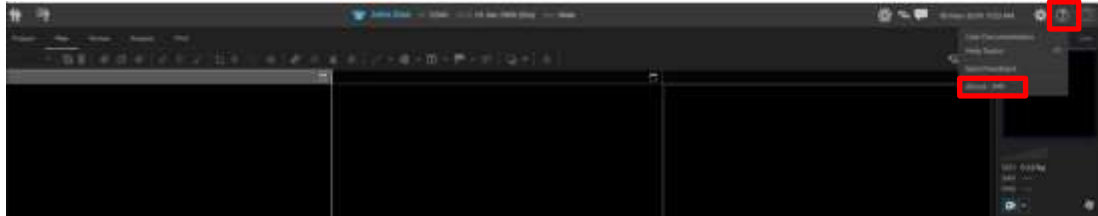
Figure 3. Initial screen on console

1. Navigate to the main screen of the operator(s) console and select the question mark symbol on the Patient Toolbar. Select the About - MR option from the drop-down list (see Figure 3).
