Urgent Corrective Action

ZOLL G5 Semi-Automatic AED Product Family Serial Number Range: D00000276194-D00000343449

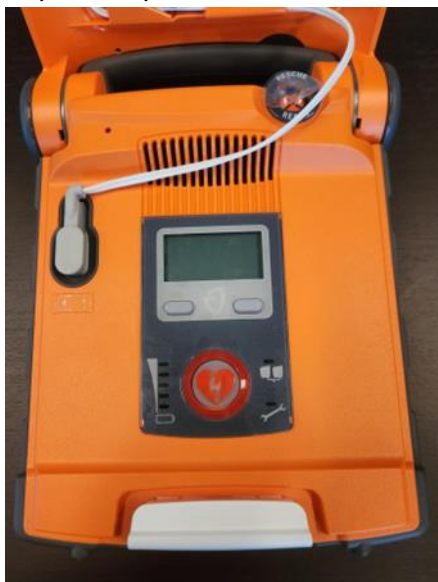
The G5 Semi-Automatic AED is shipped, with a protective film over its front panel, to protect the screen and shock button from cosmetic damage during shipping. It has come to our attention that customers may not be removing the protective film during deployment of the product. If the protective film is left adhered to the front bezel it may prevent the user from actuating the shock button. This may lead to a delay or prevent delivery of defibrillation therapy to a victim suffering from sudden cardiac arrest. We are asking customers with affected units to ensure the protective film has been removed in accordance with the provided photos in **Appendix A**.

Figure 1: Device with the protective film over the front panel, if present.

- (1) Alert G5 Semi-Automatic AED users of this problem.
- (2) Locate the affected devices.
- (3) Remove the protective film in accordance with Appendix A.
- (4) Respond to ZOLL via the customer notification form acknowledging that the protective film has been removed.

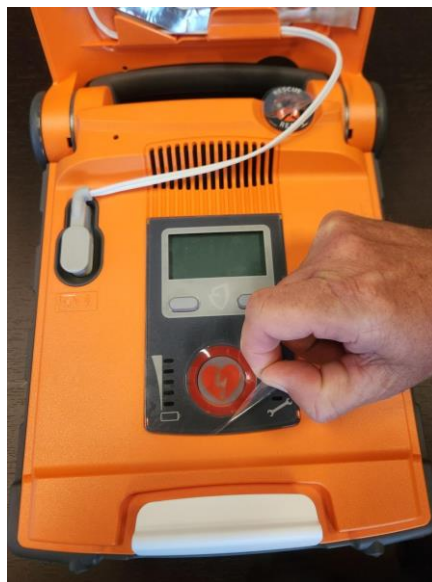
Figure 2: Remove the protective film by lifting it from its edge, if present.

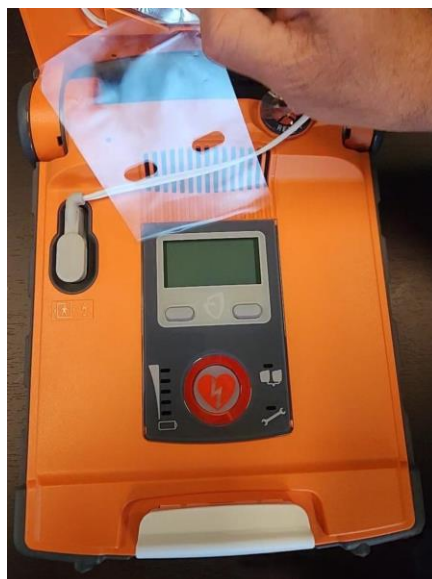
Figure 3: Discard the protective film.
