# URGENT: FIELD SAFETY NOTICE

## Medima P100, P200, and P300 Volumetric infusion Pumps

9<sup>th</sup> January 2025

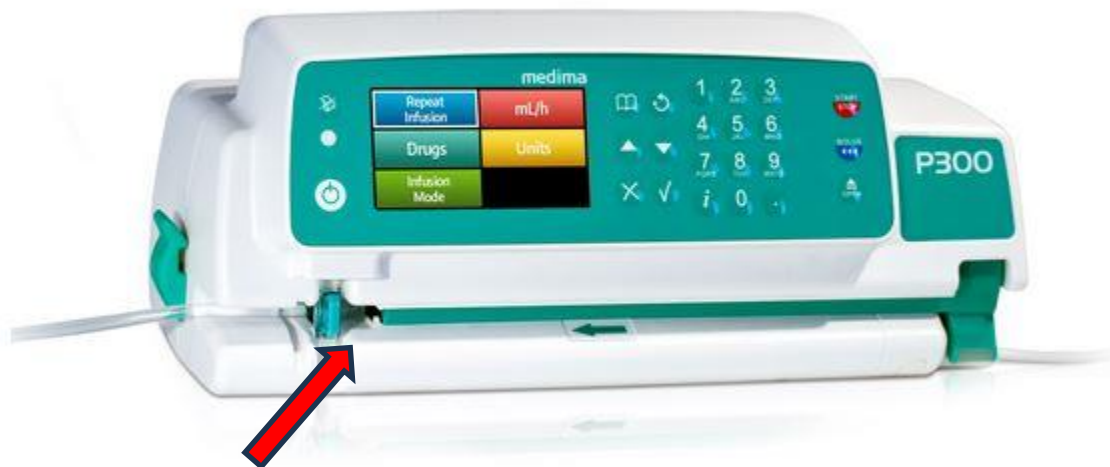
Our stepper motor supplier informed us of a potential issue due to an error in their manufacturing process with a specific lot of the stepper motors used to load and release the Free-Flow Protection Clamp (loading and releasing the pump set line). This manufacturing issue can lead to the pump runaway (shown in Figure 1 below) not opening to allow the infusion set to be inserted into the pump.

Medima has developed a software patch to mitigate the issue described in this Field Safety Notice.

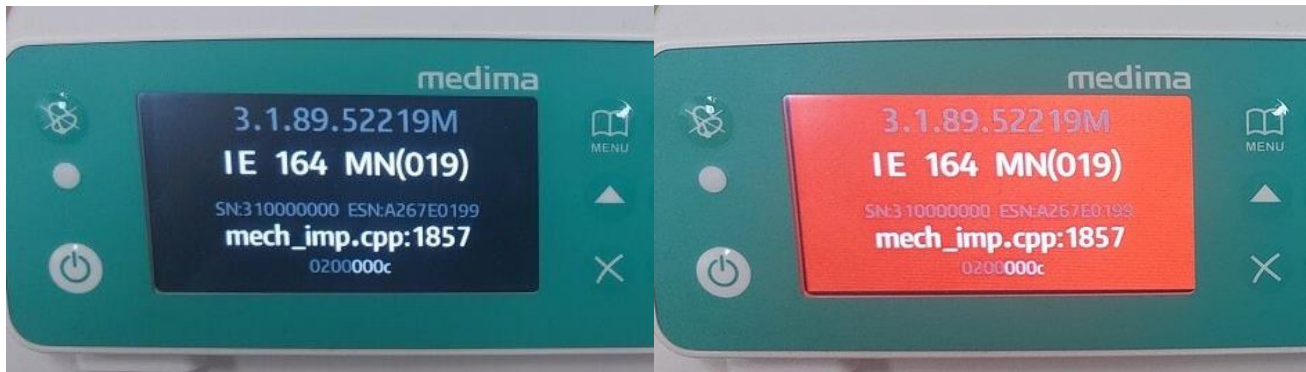
- You can continue to use your Medima volumetric pumps following the recommendations below.
- If the issue occurs, the pump displays an alarm message indicating that the pump cannot be used. The alarm is an alternating red and black animation with an audible signal, as shown in Figure 2 below.
- If this alarm occurs, please contact Medima to make arrangements to service the affected pump.

Figure 2 – Image of alarm screens if the issue occurs
