Date: January 2025

Urgent: Field Safety Notice - Initial Dexcom G6 Receiver – FAS-SD-24-003 - US-MF-000010694

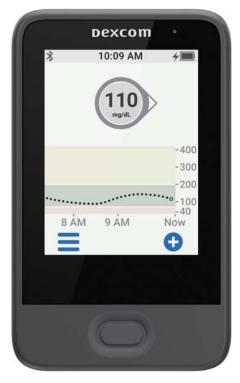
Front of Receiver Example Rendering:

The part number is listed on the back of the receiver as shown in the image to the right/below:

Note: If your receiver does not look like the images above and has a different part number, then it is not affected.
