06 Aug 2026

**URGENT FIELD SAFETY NOTICE**

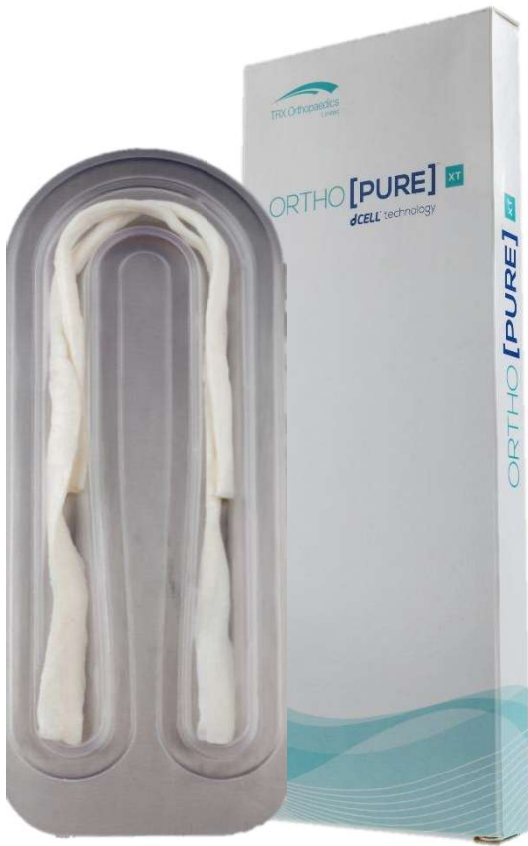
**Problem Description:**
